Coon Creek Watersheds Design Alternatives Public Scoping Meeting

June 23, 2021 | M&E Consultant Team

Project Purpose

**Flood prevention
and damage
reduction in the
watersheds.**

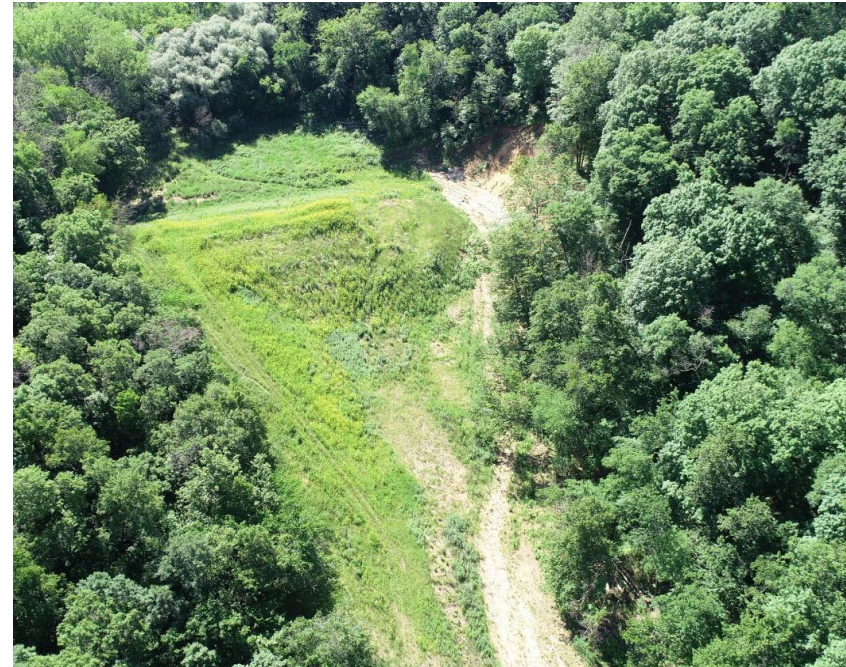
Dam Decommissioning

Excavate notch in the dam
to pass 100-yr storm

Grade slopes to a 2:1 slope

Embankment not removed
completely

Remove riser and outlet
then grout pipe shut

No sediment removal
included

- Annual CC Basin sediment produced = **98K tons** (*Based 2009 Trimble Study*)
- Total sediment accumulated behind each failed structure = **12K tons**

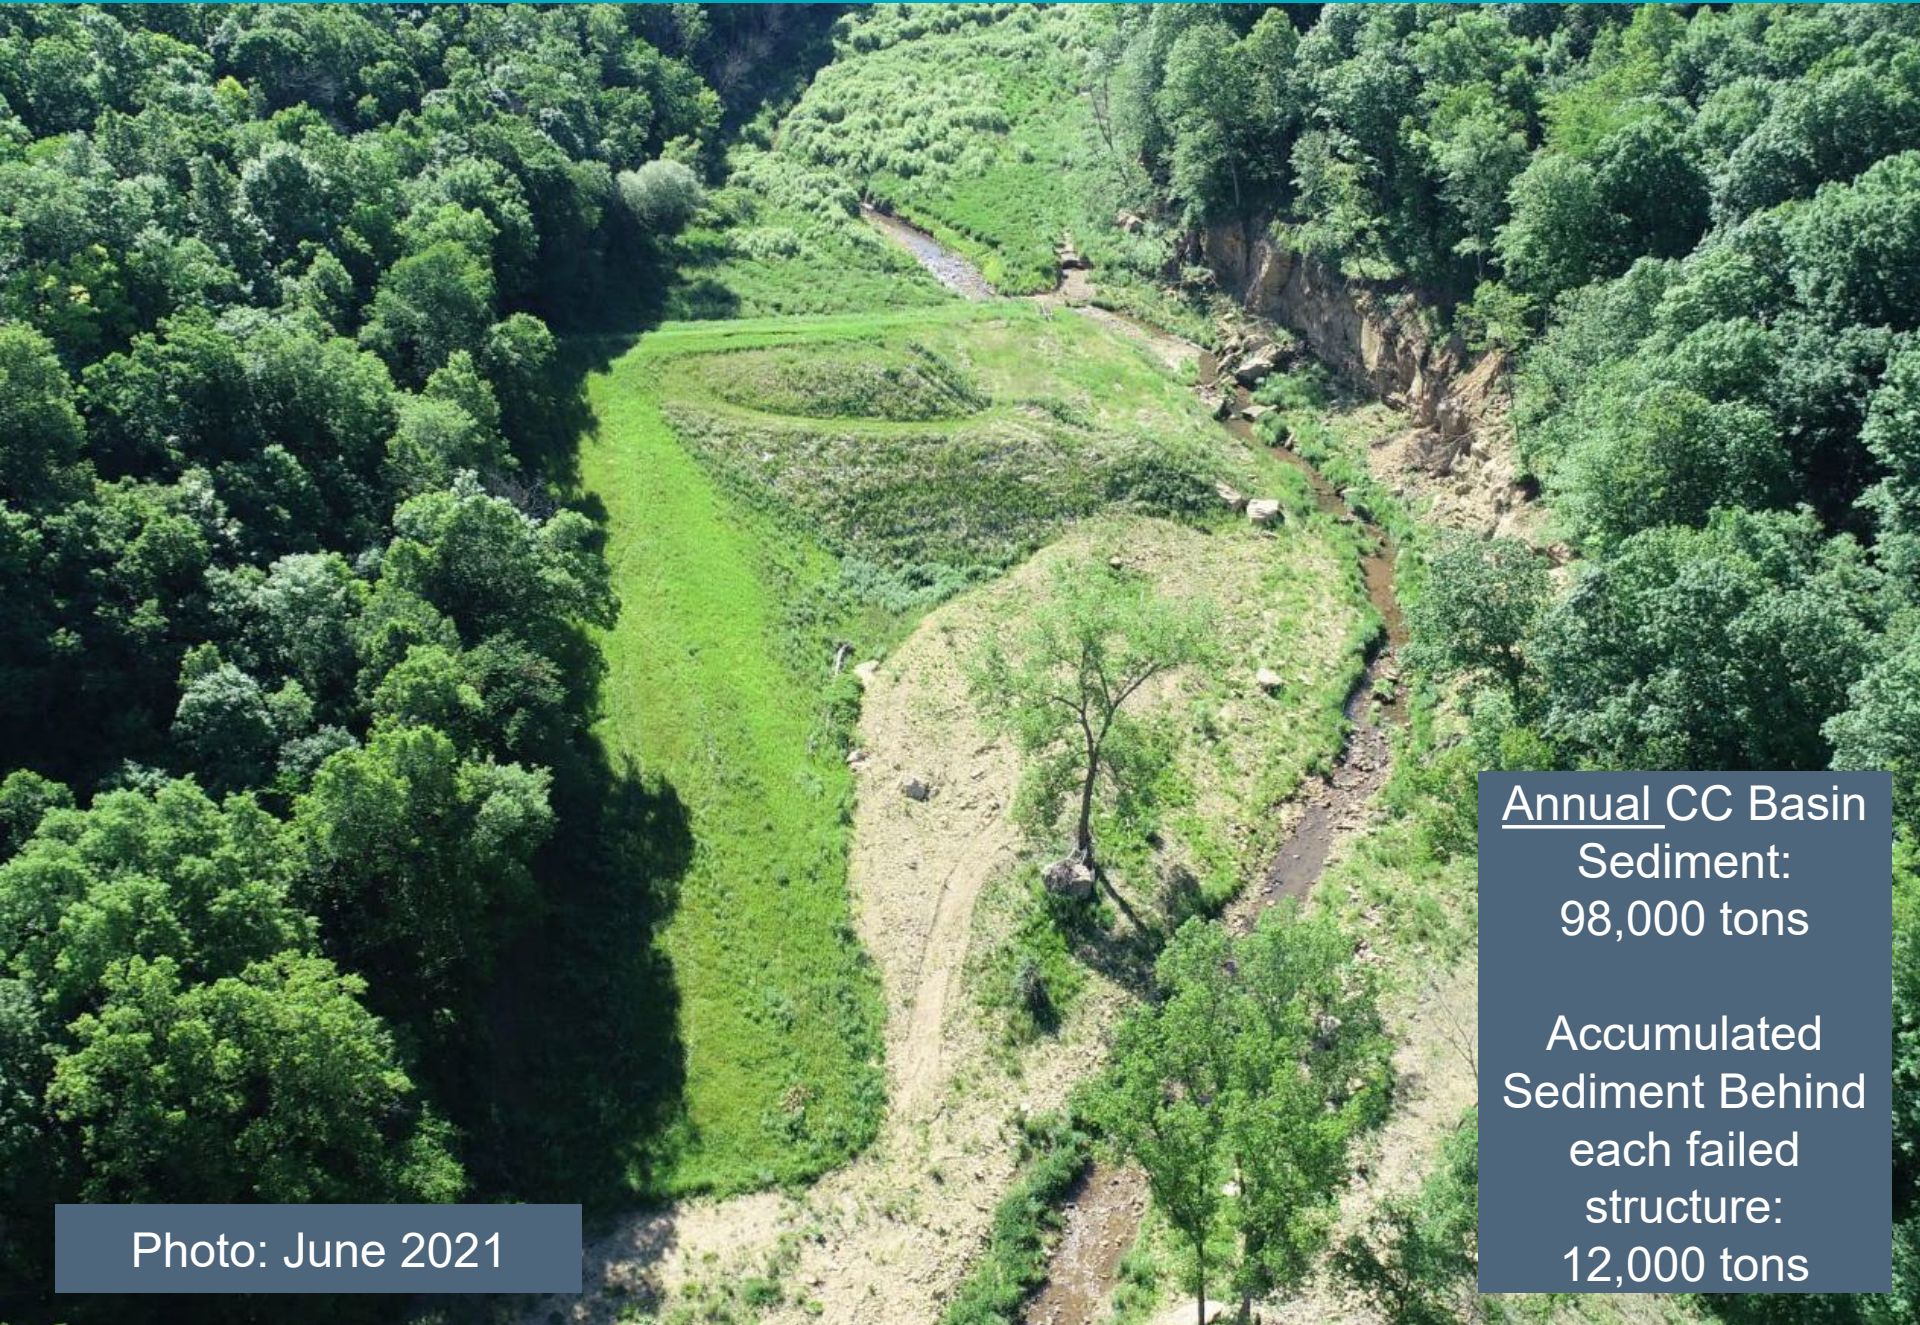
Photo: June 2021

Annual CC Basin
Sediment:
98,000 tons

Accumulated
Sediment Behind
each failed
structure:
12,000 tons

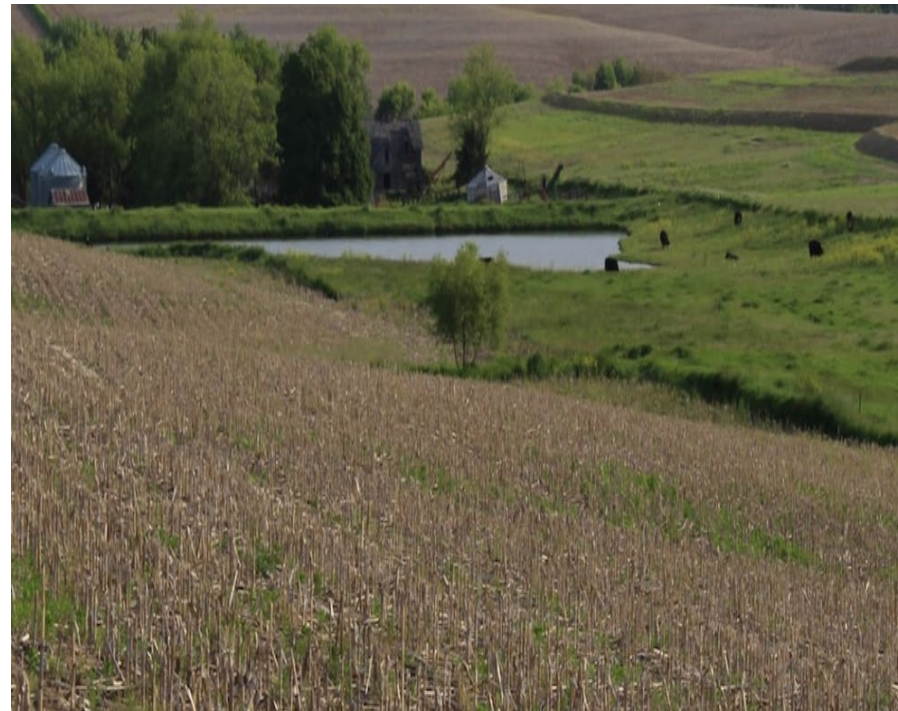
Upper Watershed Small Dams/Farm Ponds

CC 21 Luckasson Subwatershed

- 11 Small Dams
- \$650,000 Construction Cost
- Reduces the peak flow approximately 19% compared to CC 21 dam that reduces peak flow 55%
